# Elemental Analysis (EDS) Results

**Half-finished glass vessel**

The SciArt Project  
2024

## Results Report

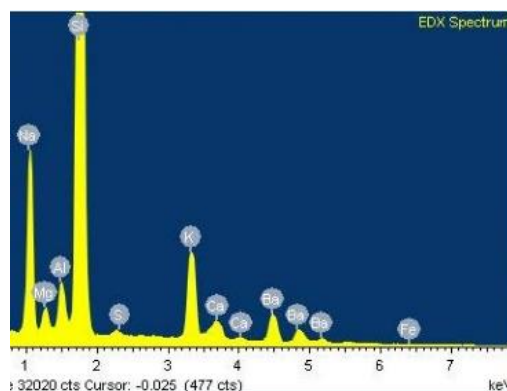
### Point of Interest 1: Main body of the vessel

This is the spectrum that was collected from the EDS analysis performed on the main body of the vessel. It is mainly composed of silicon, calcium, sodium, aluminum, potassium, iron, manganese, phosphorus and antimony.

Antimony and manganese are used to decolourize glass. Iron is responsible for the green tint of the glass (slight green color). Phosphorus is an indication that fly ash was used as an opacifier during the glassmaking. The presence of a decolourizing agent confirms that the glass has been reused.

Silicon (Si)	70%
Calcium (Ca)	10%
Sodium (Na)	1.2%
Aluminum (Al)	2.2%
Potassium (K)	2.5%
Iron (Fe)	1%
Manganese (Mn)	1%
Phosphorus (P)	0.5%
Antimony (Sb)	1.8%

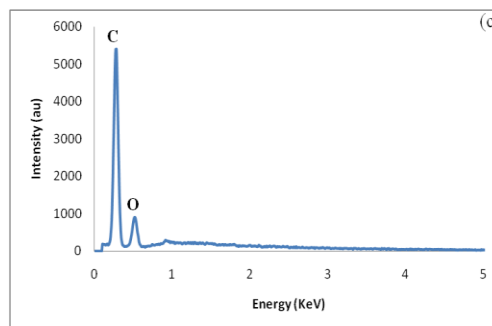
### Point of Interest 2: Crack

This is the EDS spectrum of the substance collected from Point of Interest 2. The elemental analysis shows that it is composed of carbon and oxygen. These elements are characteristic of organic materials and they are an indication that the foreign substance found in the crack is of organic origin.

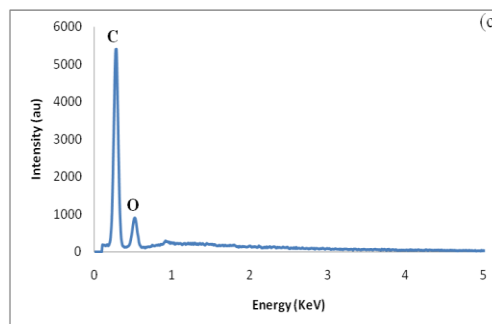
### Point of Interest 3: Residues at the bottom of the vessel

This is the EDS spectrum of the residues collected from Point of Interest 3. The elemental analysis shows that it is composed of carbon and oxygen. These elements are characteristic of organic materials and they are an indication that the residues found inside the vessel are of organic origin.
